# Uniform Residential Appraisal Report

Grayhawk Addition Ph 1, Block 1, Lot 24; & House

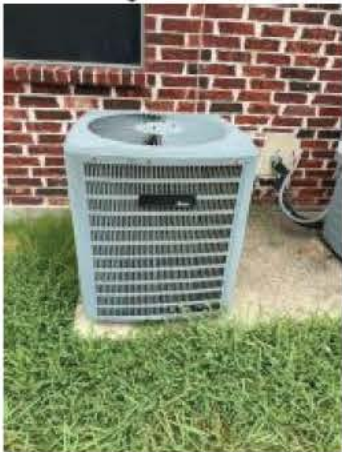
AC Unit

Quality rated Q3 based on two-story design with multiple gables/arched entry, mixed masonry exterior (brick with stone accent and stucco section), and a large covered rear patio with exposed wood framing and decorative braces. Condition rated C3 reflecting maintained exterior surfaces and site improvements with no visible deferred maintenance; only minor wear noted at HVAC condenser and typical garage floor staining.

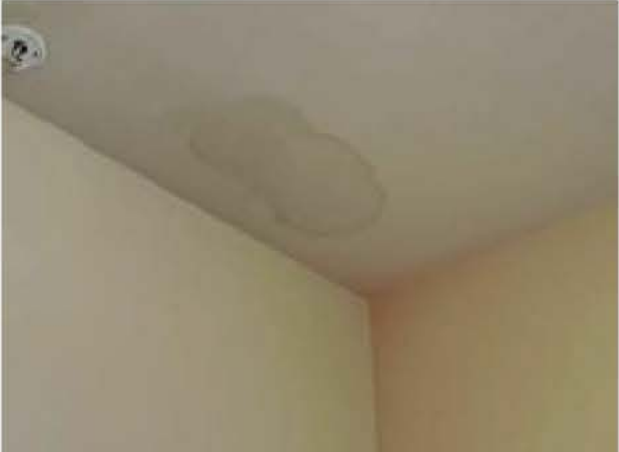
| <div>Level 1 - Bedroom</div> <div></div> | <div>Level 1 - Ceiling Detail 1</div> <div></div> |

| Interior Features | | | | |
|---|---|---|---|---|
| Walls and Ceiling | 10 or more feet Vaulted Tray Flat Arched openings; crown molding at tray ceiling; textured ceiling in upper family room | | Typical Wear and Tear | Ceiling patching/staining at one location |

| Apparent Defects, Damages, Deficiencies (Unit Interior) | | | | |
|---|---|---|---|---|
| Walls and Ceiling | Ceiling Detail 1 | Ceiling patching/discoloration at corner per the borrower the cause of the staining has been repaired. No further inspection is required. | No | None |

The cost to cure the single noted instance of deferred maintenance (damaged sheetrock ceiling) is estimated at less than \$500. Given the relatively minor nature of this item and the reasonable likelihood that the comparable sales utilized may have similar isolated instances of deferred maintenance, no adjustment was applied in the Sales Comparison Approach.

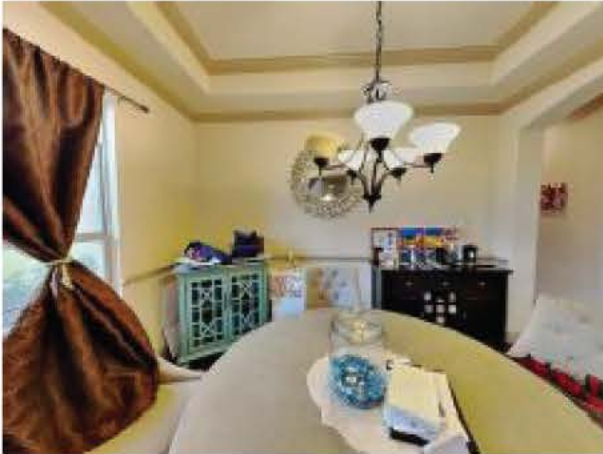
Walls and Ceiling - Trayed Ceiling

A photograph of a dining room featuring a tray ceiling with recessed lighting. A round table is set with a white tablecloth and a centerpiece. A chandelier hangs from the ceiling. A window with brown curtains is visible on the left.

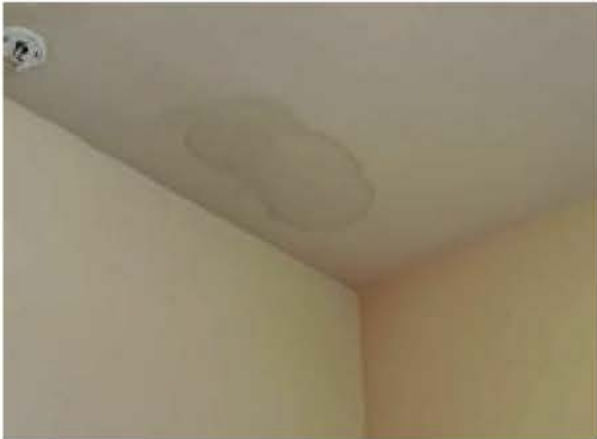
Apparent Defects, Damages, Deficiencies - Walls and Ceiling - Stained Ceiling

A close-up photograph of a ceiling showing a large, irregular water stain.

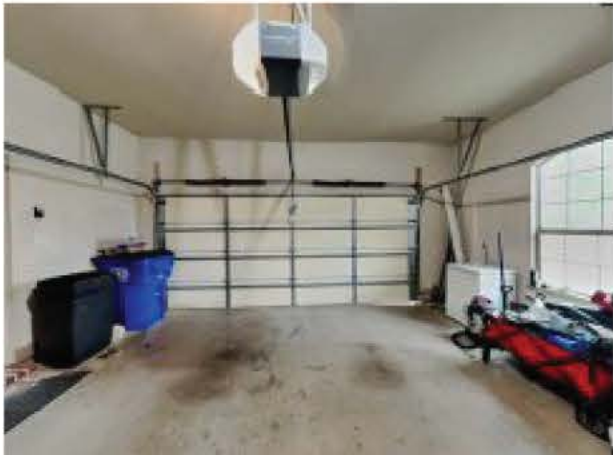
Garage - Interior View of Garage

| Feature | Location | Description | Affects Soundness or Structural Integrity | Recommended Action |
|---|---|---|---|---|
| Garage | Garage floor | Concrete floor staining/marks consistent with typical garage use. | No | None |
